# Manhole Inspection Summary

Manhole # S61K\_\_009MH

Insp Date: **3/21/08 10:50 AM**

**Location** Address: **800 Rappolla St.**

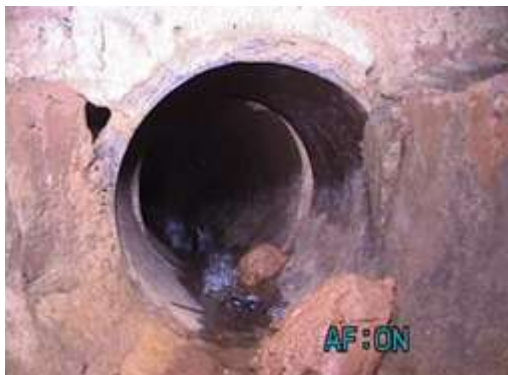
Defect 3

Void visible 10:00 incoming 3:00.

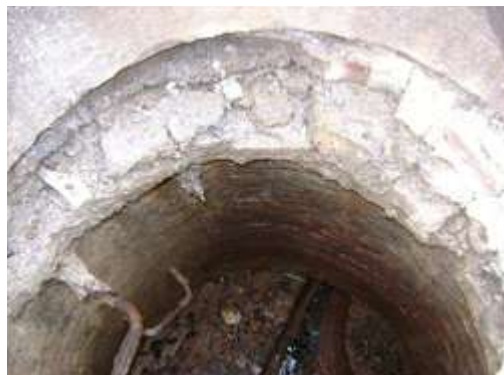
Defect 4

Offset: **4** (in.)

Frame offset defect

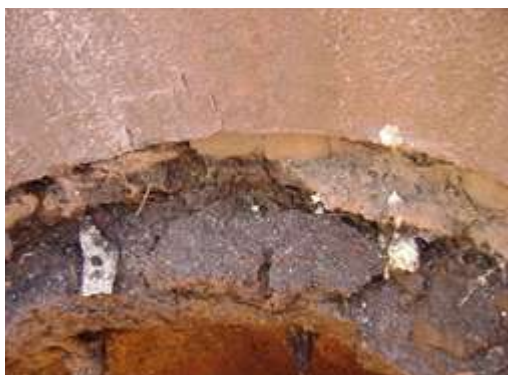
Defect 1

Condition: ☐ Sound ☐ Cracked ☐ Root Intrusion ☒ **Loose Brick** ☒ **Deteriorated**

Infiltration: ☐ None ☒ **Joint** ☐ Cracks ☒ **Mortar** ☐ Roots ☒ **Wall**

Deterioration at chimney

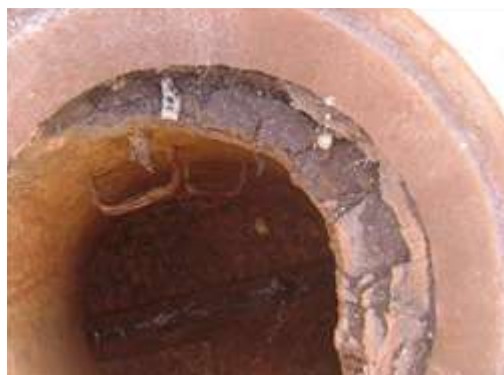
Defect 2

Offset frame defect

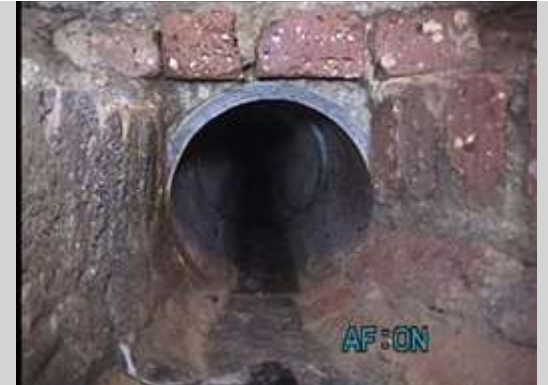
12 O'Clock Outflow

Pipe Height: **8.4** (in.) Rod and Bar (Angled)  
Pipe Material: **Clay** ☐ Pipe Lined  
Invert Depth: **7.33** (ft.) Flow Characteristics: **Fast**  
Deposits: ☒ None ☐ Mud ☐ Sludge ☐ Debris ☐ Grease  
Silt Depth: (in.) Deposits Extent:  
Infiltration: **None** Pipe Seal Cond: **Sound**

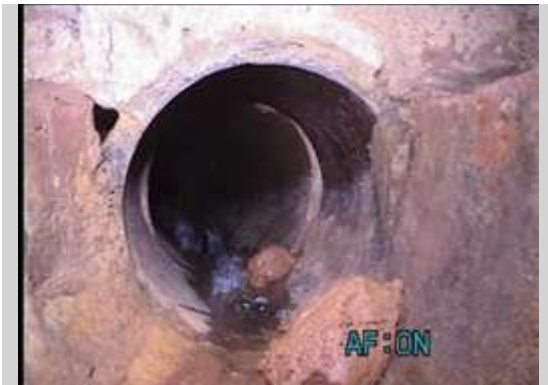
3 O'Clock Inflow

Pipe Height: **8.4** (in.) Rod and Bar (Angled)  
Pipe Material: **Clay** ☐ Pipe Lined  
Invert Depth: **7.08** (ft.) Flow Characteristics: **Fast**  
Deposits: ☒ None ☐ Mud ☐ Sludge ☐ Debris ☐ Grease  
Silt Depth: (in.) Deposits Extent:  
Infiltration: **Evidence** Pipe Seal Cond: **Broken**

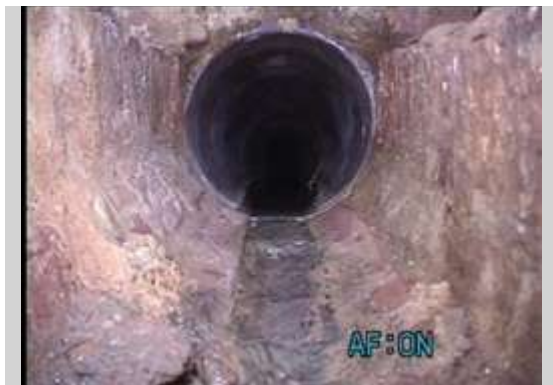
6 O'Clock Inflow

Infiltration: **None** Pipe Seal Cond: **Sound**
